LEWIS-CLARK VALLEY MPO

Public ADA Facilities Inventory

Final Report 2014 Addendum

*Supplemental ADA
Transition Plan Inventory of
Public ROW Facilities*

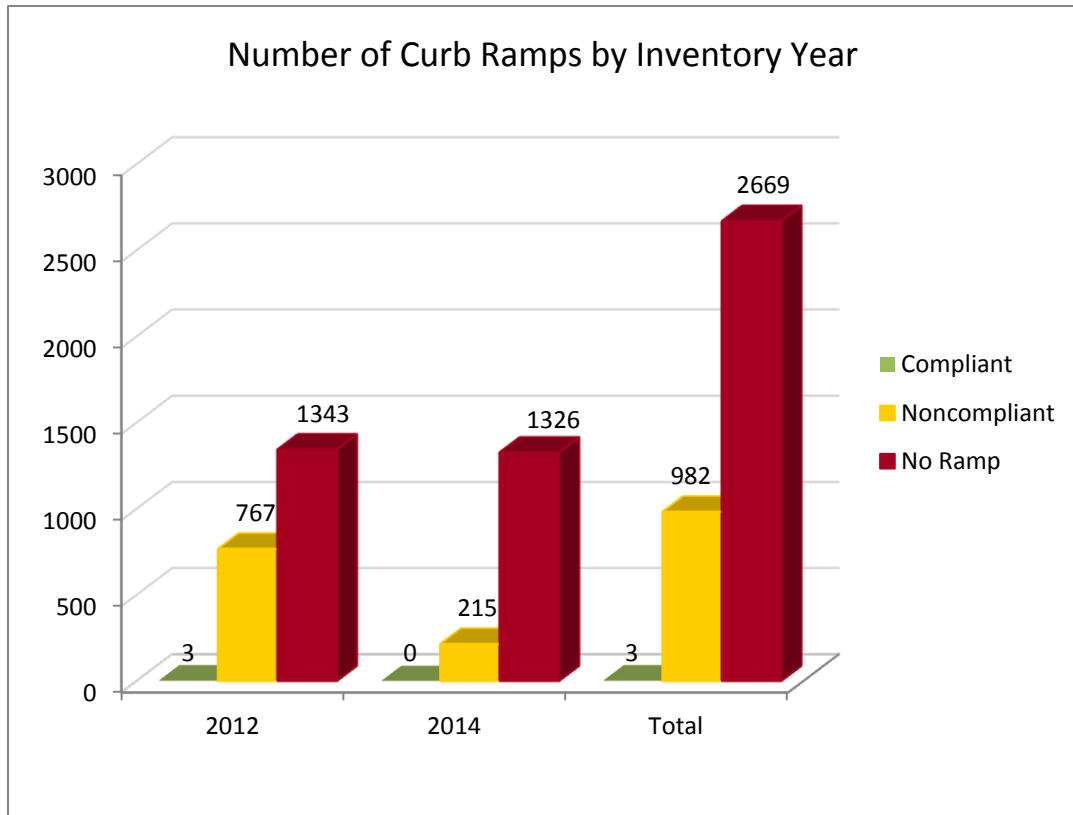
Figure 1. Number of Curb Ramps in the City of Lewiston by Inventory Year

Of the 1,541 curb ramp locations inventoried throughout the City of Lewiston in 2014, there were 1,326 locations that did not have a curb ramp, 215 locations that were noncompliant and zero locations that were compliant with all ADA requirements reviewed.

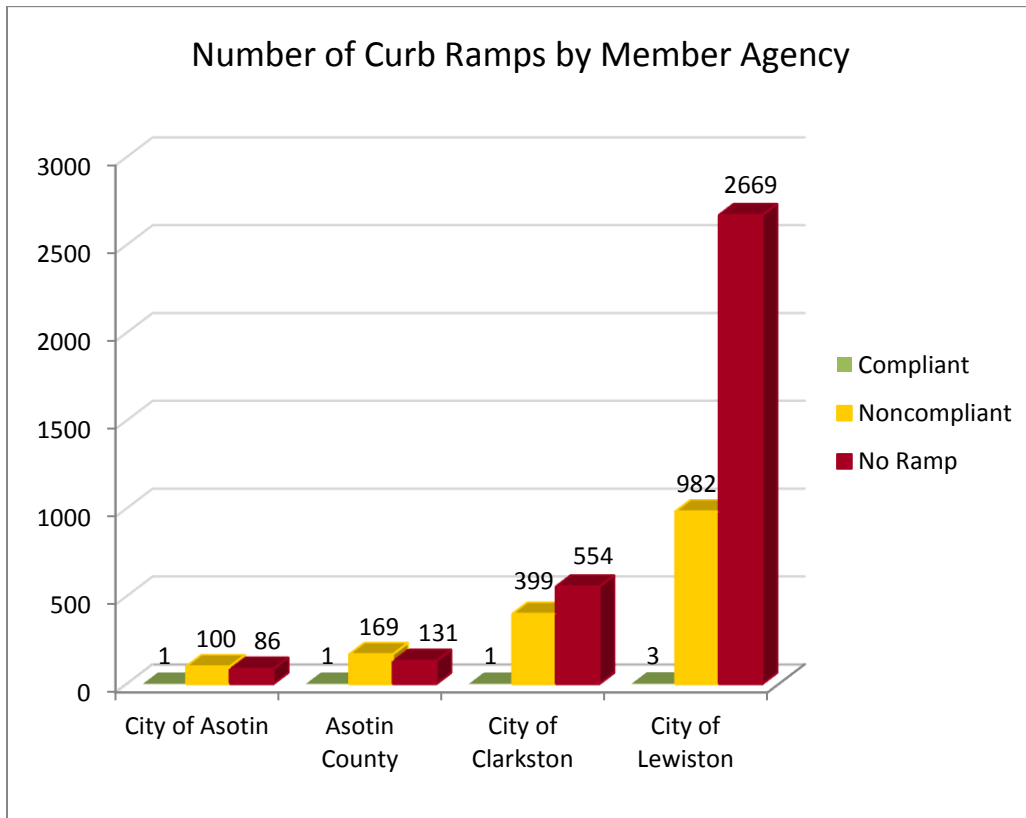
Figure 2. Updated Number of Curb Ramps by Member Agency

From 2012 to 2014, a total of 3,654 curb ramps were inventoried in the City of Lewiston. Of those, there were 2,669 locations that did not have a curb ramp, 982 locations that were noncompliant and 3 locations that were compliant with all ADA requirements reviewed.

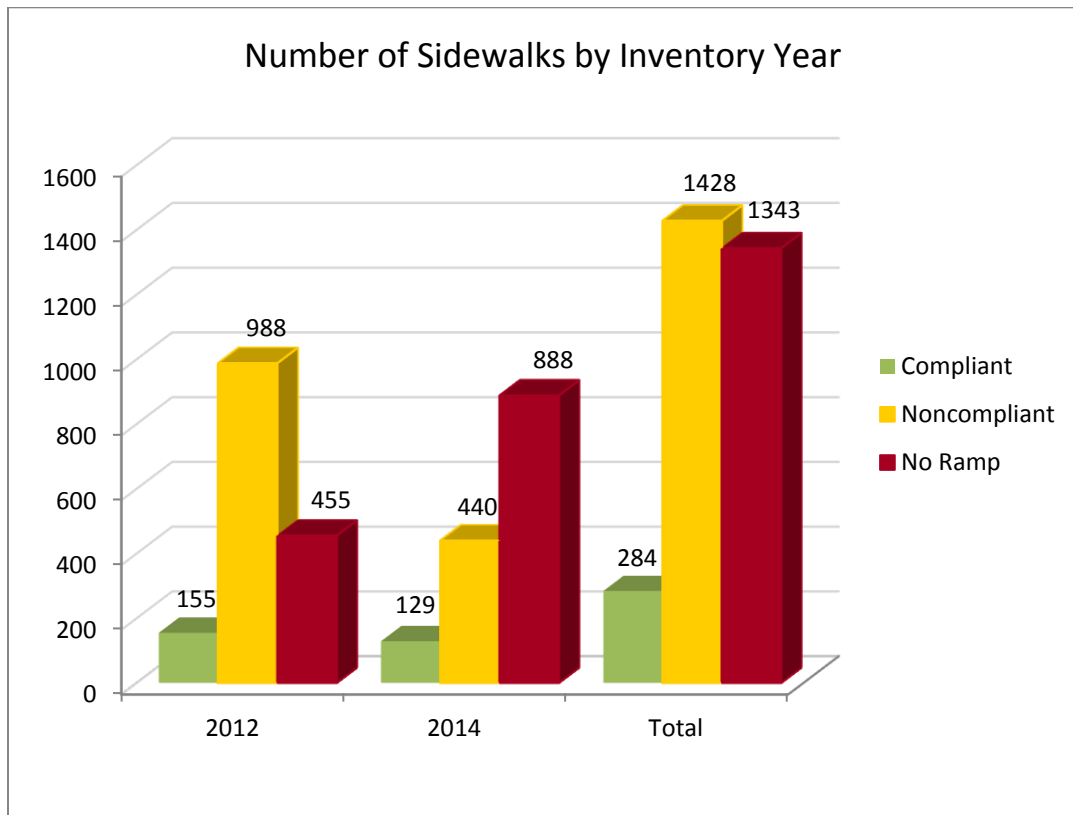
Figure 3. Number of Sidewalks in the City of Lewiston by Inventory Year

Of the 1,457 sidewalk segments inventoried throughout the City of Lewiston in 2014, there were 888 locations that did not have sidewalk or a pedestrian pathway, 440 locations that were noncompliant and 129 locations that were compliant with all ADA requirements reviewed.

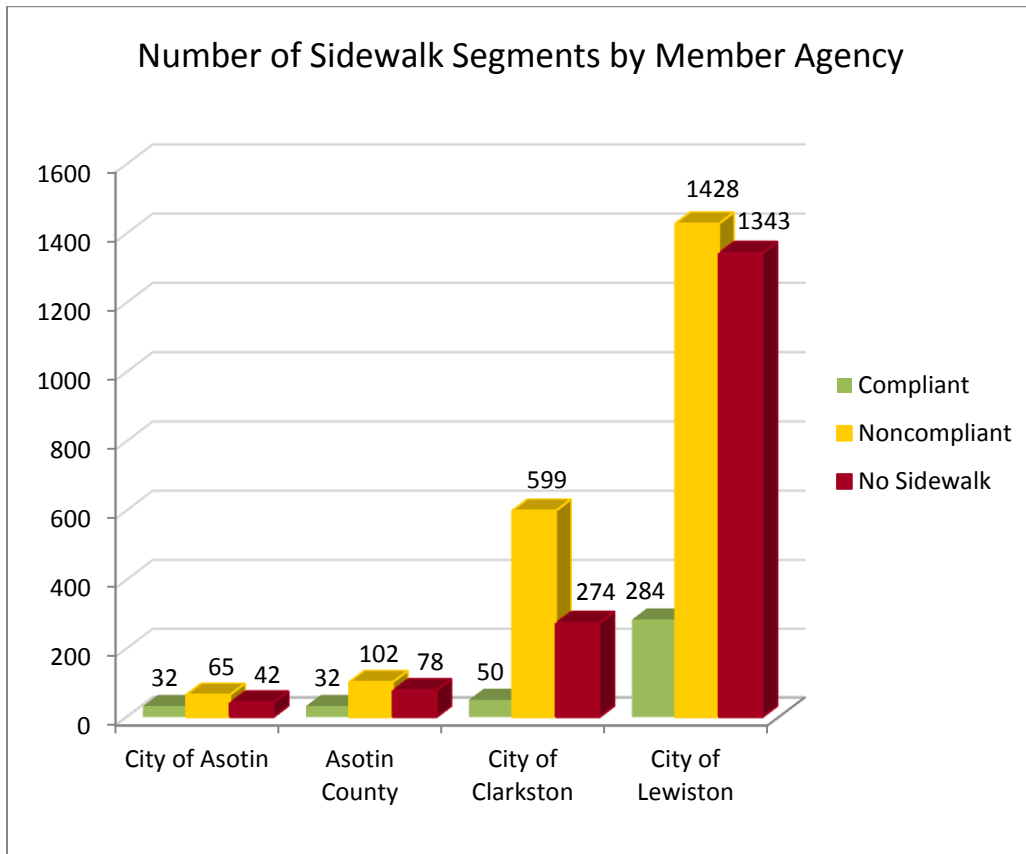
Figure 4. Updated Number of Sidewalk Segments by Member Agency

From 2012 to 2014, a total of 3,055 sidewalk segments were inventoried in the City of Lewiston. Of those, there were 1,343 locations that did not have sidewalk, 1,428 locations that were noncompliant and 284 locations that were compliant with all ADA requirements reviewed.
